**HOOPER BAY AIRPORT  
IMPROVEMENTS**

**PROJECT No. 57419**

**RECONNAISSANCE STUDY, 2005**

**STATE OF ALASKA  
DEPARTMENT OF TRANSPORTATION  
AND PUBLIC FACILITIES**

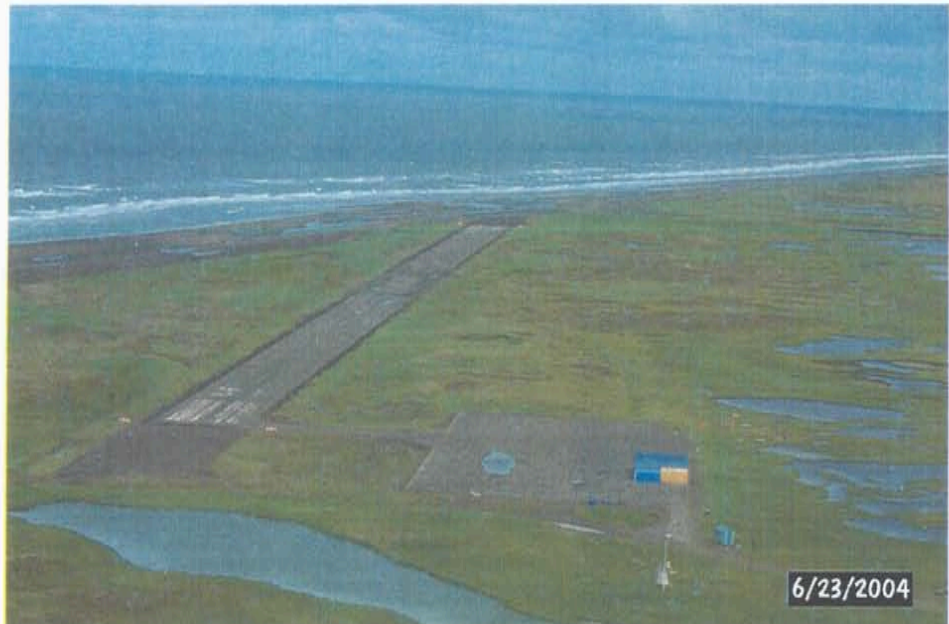
A 75' by 3300' runway currently exists with a 100' by 3900' safety area. A private hangar currently exists on the 180' by 500' apron, which is connected to the runway by a 35' by 150' taxiway. The picture, shown right, depicts the existing facilities. Medium intensity runway lighting exists along with a lighted wind cone, rotational beacon, AWOS, VASI & segmented circle (currently damaged). Runway 31 also has an Omni Directional Approach Lighting System (ODALS). A 1.5-mile access road connects the

village to the apron and a double bay snow removal equipment (SRE) building currently exists off the airport access road. The beach access road spurs off of the airport access road along the south end of the runway. Additional aerial photography has been attached as Appendix II.

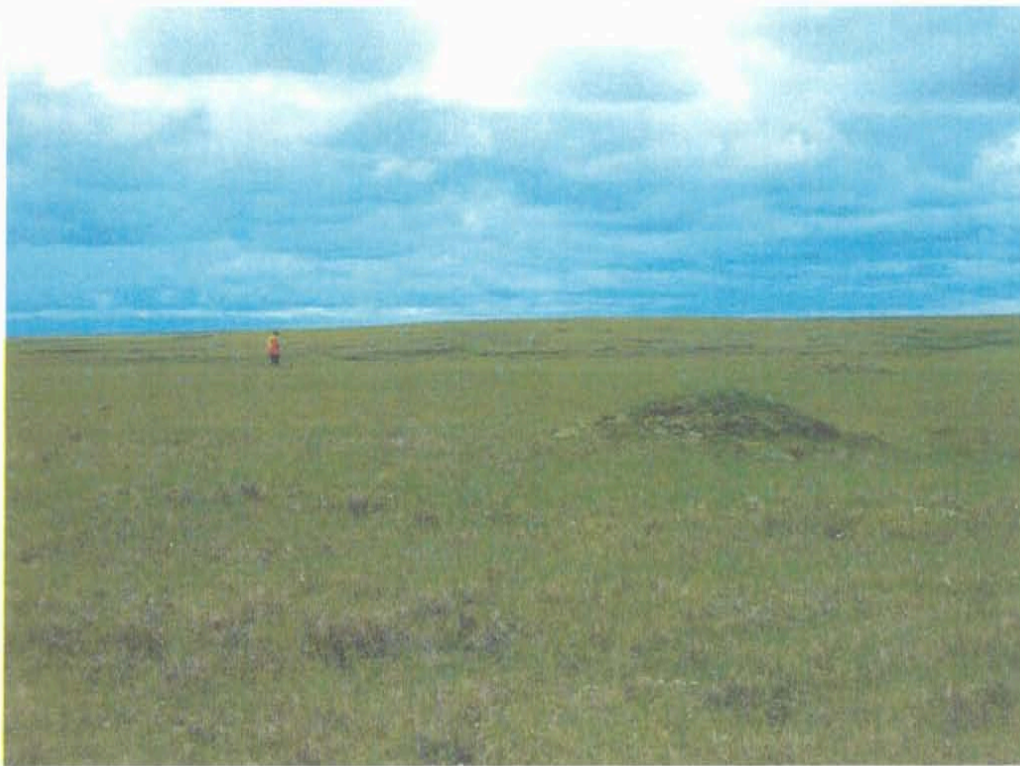
- Pingos (as shown below) are conical features up to several feet high and six to ten feet in diameter, appearing either isolated or in dispersed clusters over the terrain. Pingos are generally formed of segregated ice just below the surface. Disruption of the thermal regime of a pingo can result in a thawing sinkhole several feet deep.

Typical Pingo

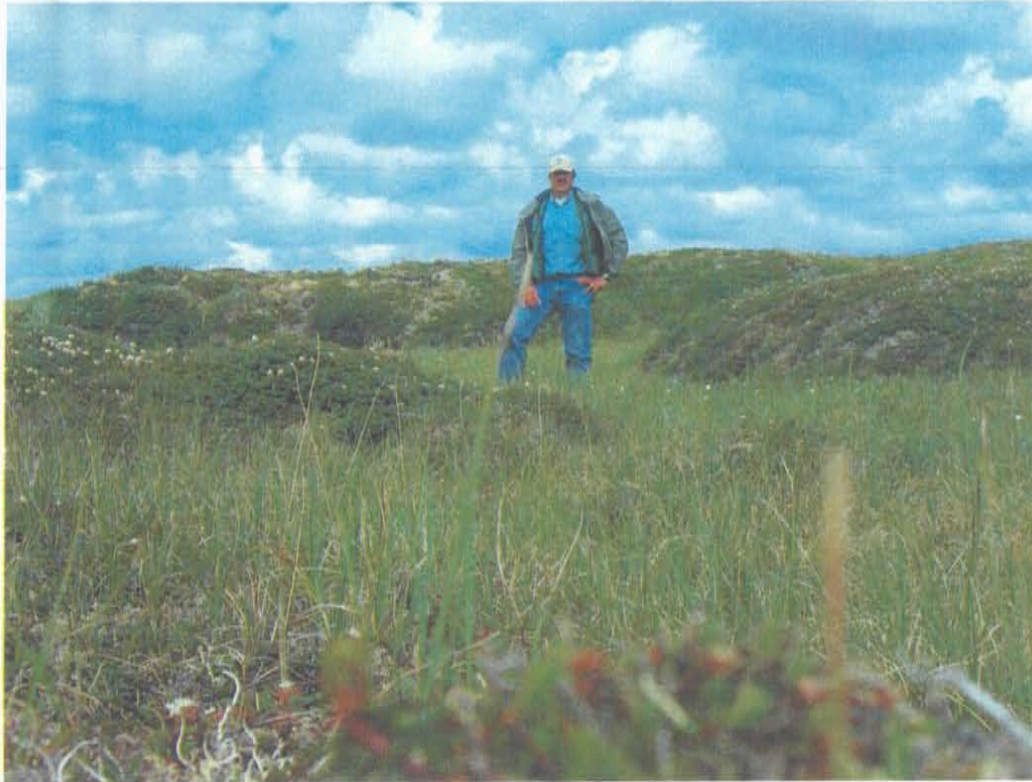
- Peat palsas (as shown in the following picture) are ice-rich peat and/or silt features, which stand above surrounding terrain by up to four feet with abrupt margins. The vegetated surfaces of palsas tend to be dryer than the immediately surrounding lowlands. Palsas can cover areas from tens of square feet to much more extensive

clusters, in the range of hundreds to thousands of square feet. They were often seen clustered along shallow slopes and across low, poorly drained basins. Disruption of the thermal regimes of palsas would result in extensive areas of soft, saturated peat and organic silt muck.

Typical Palsas

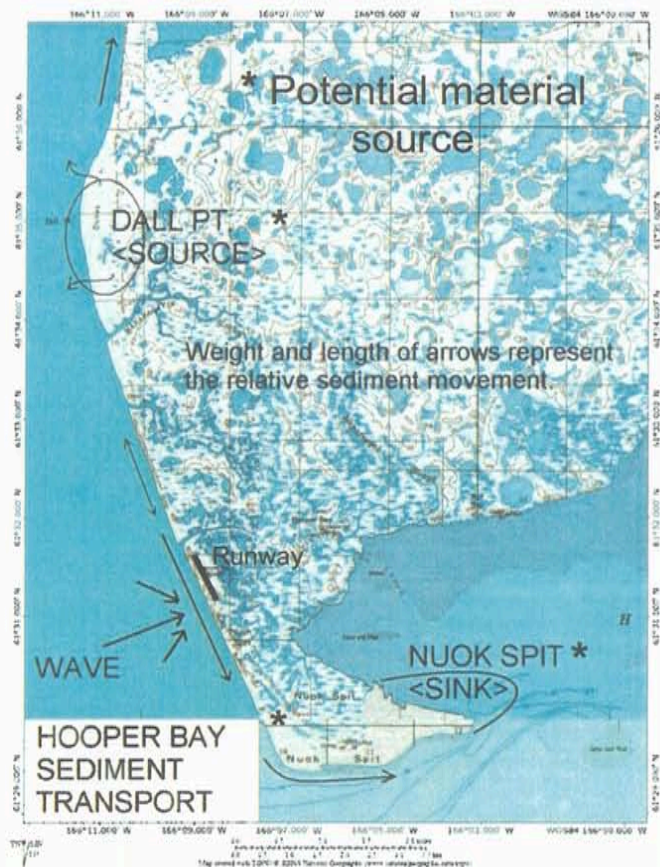
Dall Pt. (as shown right) exhibits characteristics of bi-directional transport of sediment and acts as both a sediment source and sink. Sediment moves both north and south from Dall Pt. This has potential as a material source in the event that the airport is relocated to sites 1 or 2.

Beach material parallel to the existing runway is moving south toward the spit; removal of it will have less effect on the existing runway the further south it is taken. In the event that the airport is reconstructed, it is recommended that material be mined from the beach and dunes  $\frac{3}{4}$  - to 1 mile south of the existing beach access road. It is also recommended to avoid areas where there are thaw lakes near the edge of any vegetated bluff.
